MP3-01/2/3/5 Radio for Hyundai Vehicles. Remove and Refit Instructions.

This instruction covers all the above model numbers and their suffix variants.

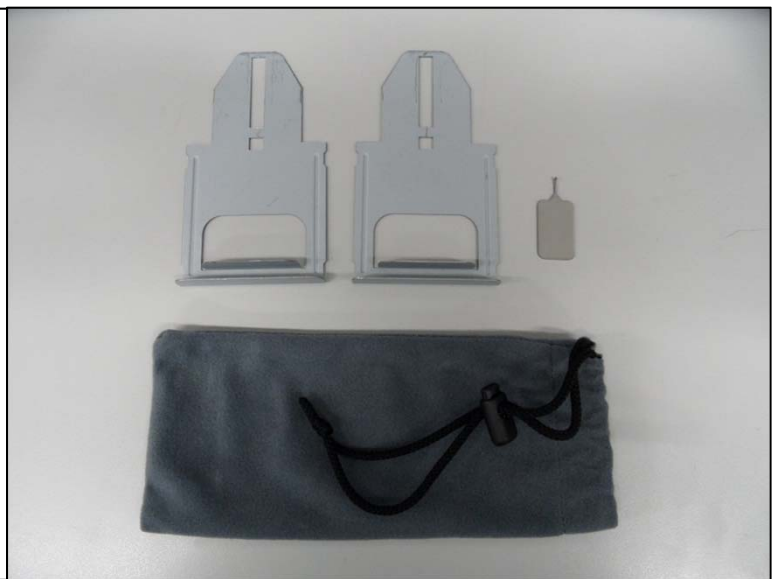
1. Preparation.
Obtain the radio removal tool kit.

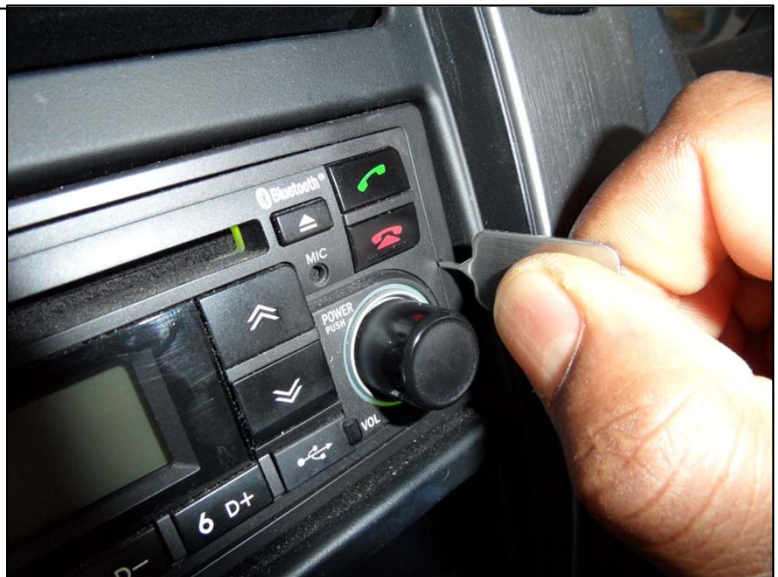
2. Insert the hook of the radio trim removal tool into the small hole between the radio front panel and attached frame trim. Pull the frame trim outward from the radio as shown. Remove the trim from the radio.

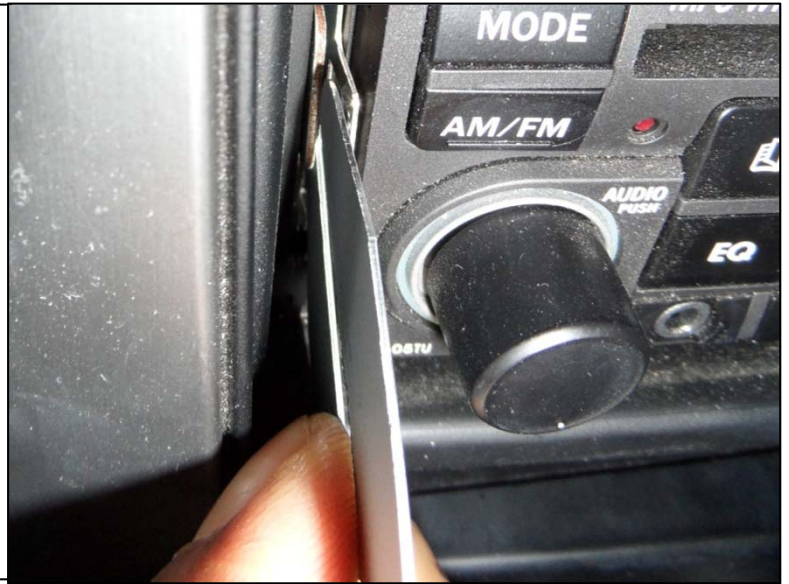
3. Insert the radio removal tool tapered edge into the gap between radio clip and the mounting frame as shown.

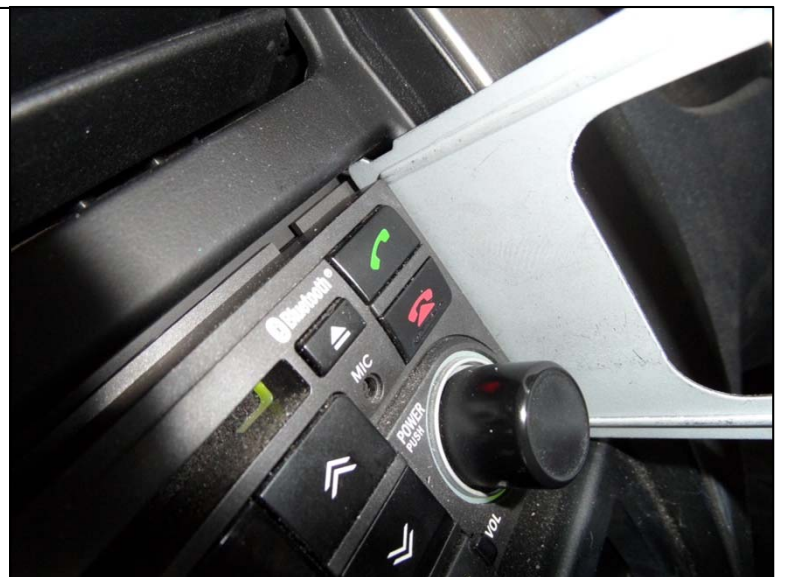
4. Push the tool into the gap until the edge of the tool is hard up and square against the radio front panel as shown. Repeat steps 3 and 4 for the opposite side of the radio.

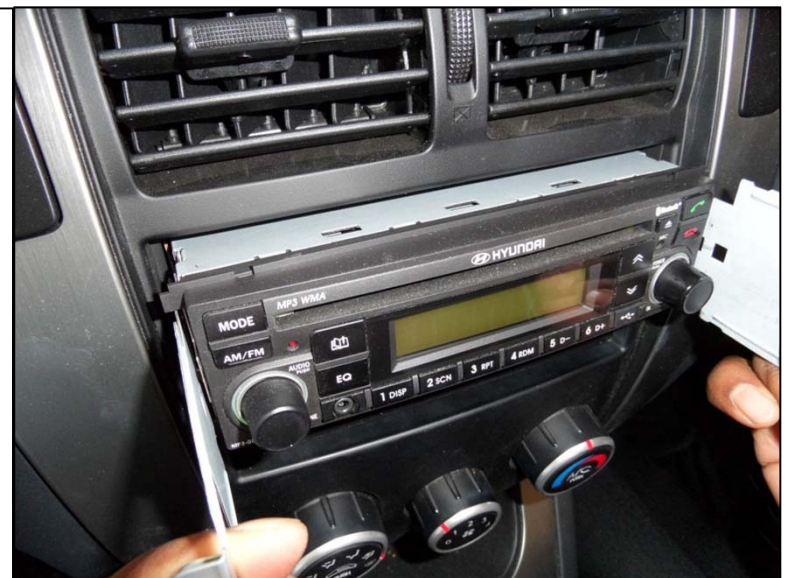
5. Grasp each tool with each hand. Pull the tools outward from the dash equally so that the radio is released approximately 80 mm from the mounting frame as shown. Remove the tools from the radio sides.

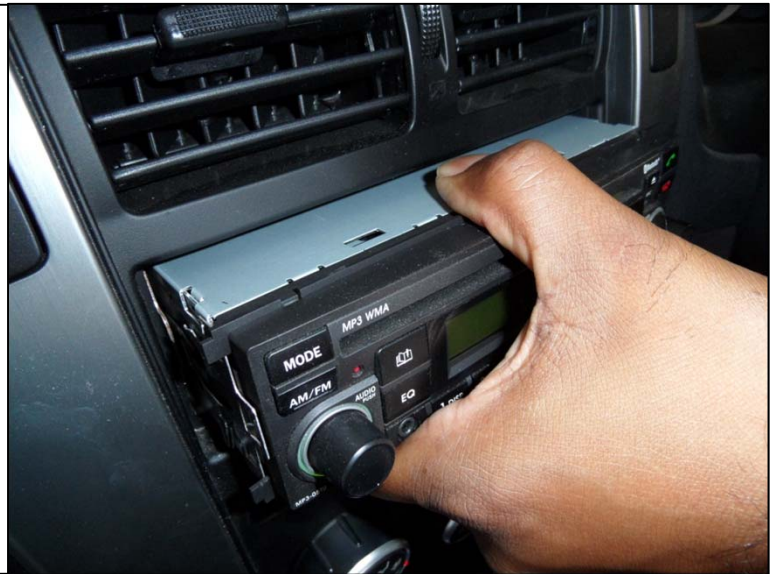
6. Pull the radio out of the dash as shown to reveal the radio rear wiring connectors.

Once removed, carefully support the radio and ensure the vehicle dash and radio front is not at risk of damage during the next step.

7. Disconnect the wiring and antenna connectors. Each connector will incorporate a locking tab that must be depressed whilst the connector is pulled away from the radio. The round antenna plug is the only connector that does not have a locking tab.
